**NEW MEXICO
ENVIRONMENT DEPARTMENT**

Re: **Raylee Luxury Homes; Construction Stormwater; SIC 1522; NPDES Compliance Evaluation
Inspection; NPDES #NMR100066; February 21, 2018**

NPDES Construction General Permit Inspection Report – State of New Mexico

**The Peaks Mariposa East
February 21, 2018
NMR100066**

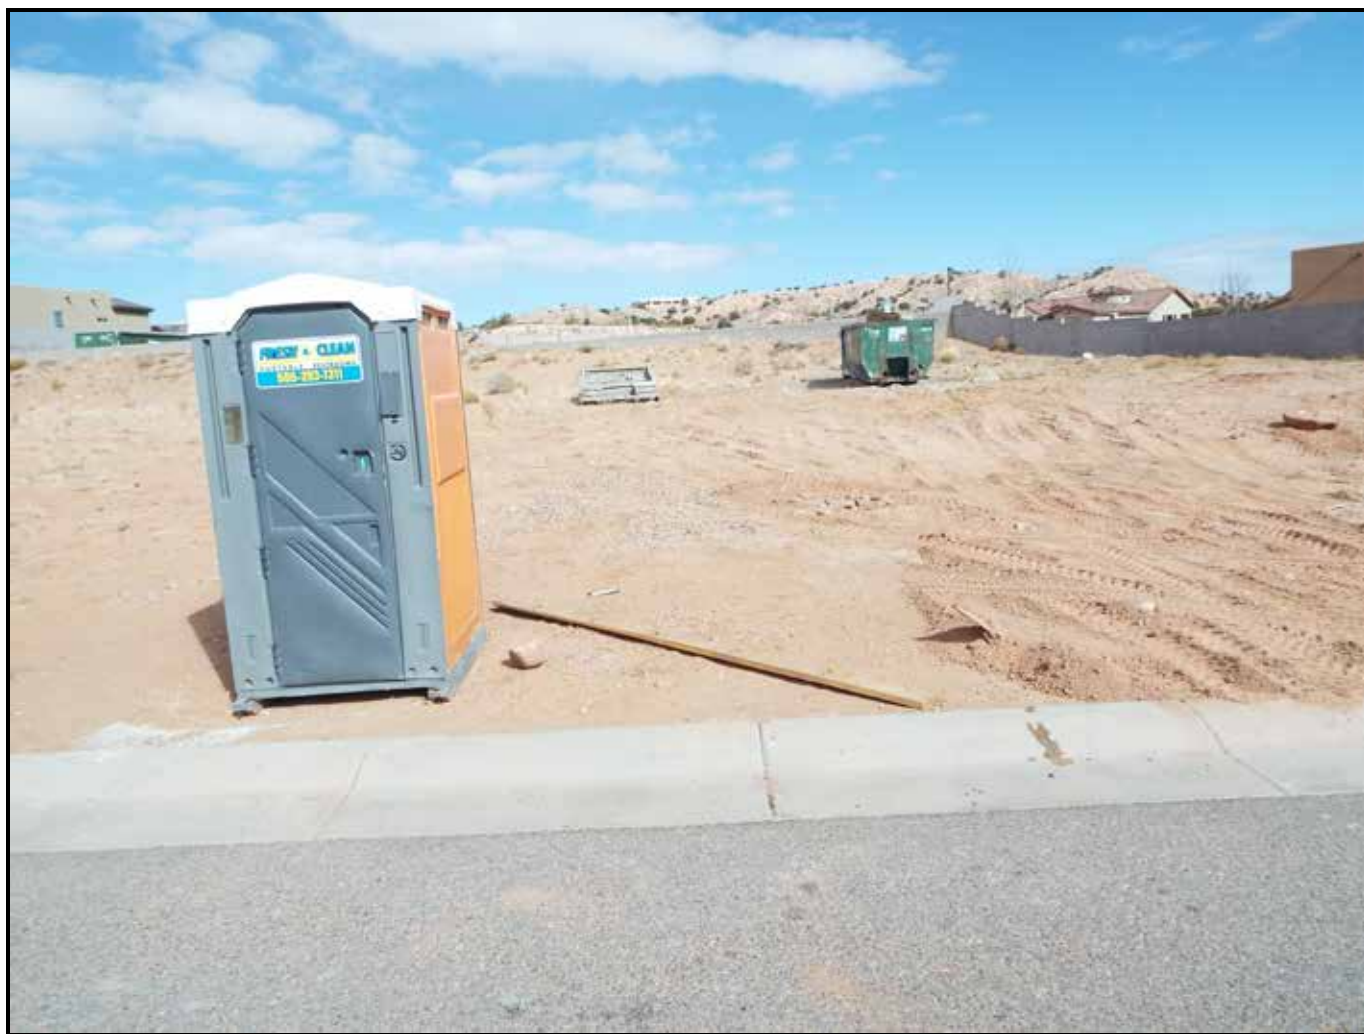
Photo # 1

- A RUSLE evaluation was present in the SWPPP. Per 9.4.1.S sediment loss during construction must not increase from preconstruction conditions. The RUSLE calculation in the SWPPP demonstrated an increase in soil loss from preconstruction of 0.07 to an increase of 0.16 during construction phase.
- On the day of the inspection each of the construction sites had a dumpster present to collect construction wastes, but without a cover and per the permittee representative stated they were not covered at night.

Photographer: Daniel Valenta	Date: 2/21/2018	Time: 2029 hours
City/County: Rio Rancho/Bernalillo		
Location: Blue Grama NW & Castle Peak Loop		
Subject: Staging lot, portable toilet staked down, cement washout in background. Waste bin has no cover.

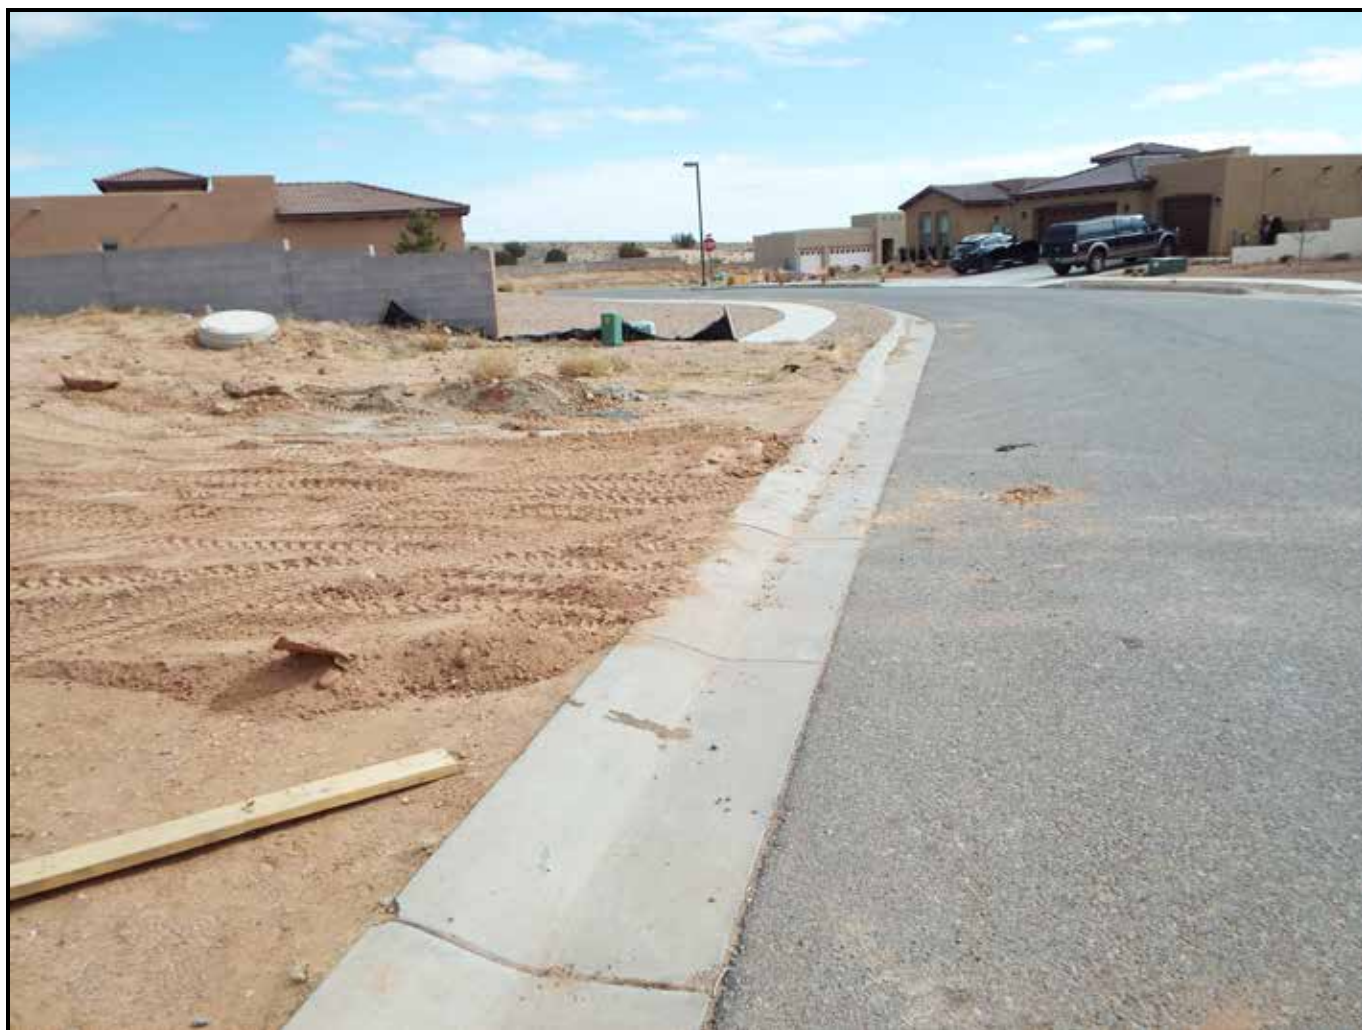
Photo # 2

- Slight track out from the sites was observed on the paved streets.
- Some damaged silt fences need to be repaired or replaced.
- A small amount of concrete wash out was found around the area. A washout container was present.
- A rain gauge should be present at the site to document rain events.

Photographer: Daniel Valenta	Date: 2/21/2018	Time: 1038 hours
City/County: Rio Rancho/Bernalillo		
Location: Blue Grama NW & Castle Peak Loop		
Subject: A small amount of track out can be found at the sites. Broken silt fence needs to be repaired.

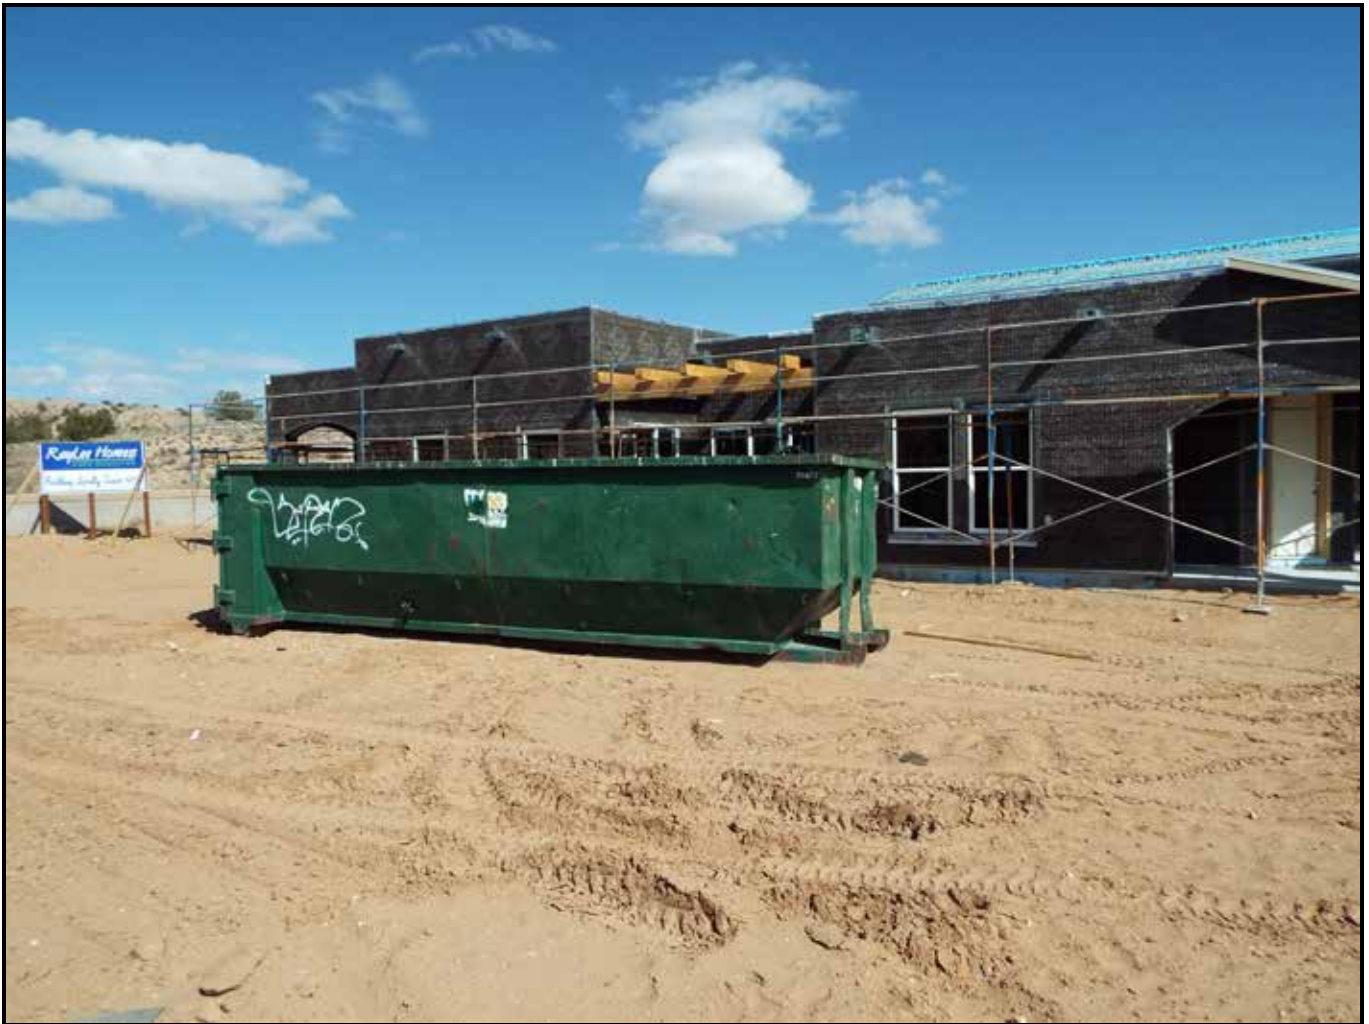
Photo # 3

Photographer: Daniel Valenta	Date: 2/21/2018	Time: 1331 hours
City/County: Rio Rancho/Bernalillo		
Location: Blue Grama NW & Castle Peak Loop		
Subject: Uncovered dumpster at another home construction site.
